## **Observation of metallurgical changes induced by an electric arc to Ag-SnO<sub>2</sub>-CuO electrodes**

# Observation of metallurgical changes induced by an electric arc on Ag-SnO<sub>2</sub> electrodes

**Abstract** — Understanding the erosion of contact materials caused by electric arcs is a major challenge to improve the lifetime of switching devices. The main purpose of this study is to determine how the silver-tin oxide material (Ag-SnO<sub>2</sub> 12%w.) evolves under the action of a unique arc and multiple arcs (up to 50,000). Pairs of electrodes were submitted to an opening arc at room atmosphere for current intensity of 150, 300 and 600 A rms and typical duration of 4 ms. Different means of characterization were used: optical microscopy, optical profilometry, energy dispersive spectroscopy (EDS) of the electrode surface, electron backscatter diffraction (EBSD). For a unique arc, it was possible to observe a resolidified molten zone and estimate its dimensions. The influence of the number of arcs has been studied and a gradual evolution of the damage nature has been demonstrated as a function of the arc numbers.

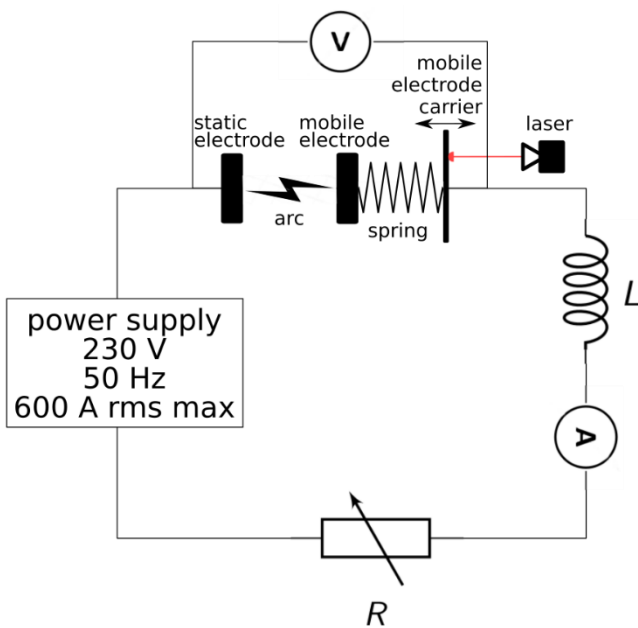
Fig. 1. Electrical circuit diagram; three values of resistances are used to get three current values 150, 300 and 600 A rms; the inductance value is set to get  $\cos(\varphi)=0.35$ ; this machine enables to generate one or several arcs.

A schematic description of the electrical circuit considered in this work is shown in Fig. 1. The power supply is an alternative voltage source (230 V rms at 50 Hz) which can deliver a current up to 600 A rms. The current value is fixed by the choice of the resistor value. In this work, we focus on three current intensity values: 150, 300 and 600 A rms. The current in the circuit and the voltage measured between electrodes are recorded. The mobile part of the device is constituted of an electrode, a spring and a mobile electrode carrier. The spring ensures a contact force of 10 N. A laser measures the displacement of the mobile electrode carrier. As soon as the contact is open (contact force equals 0), this displacement corresponds to the electrode gap and it opens at a constant speed of around 0.4 m/s. This device has been used to generate a controlled number of opening arcs: from 1 to 50,000 arcs. Each making-breaking cycle lasts 1 second.

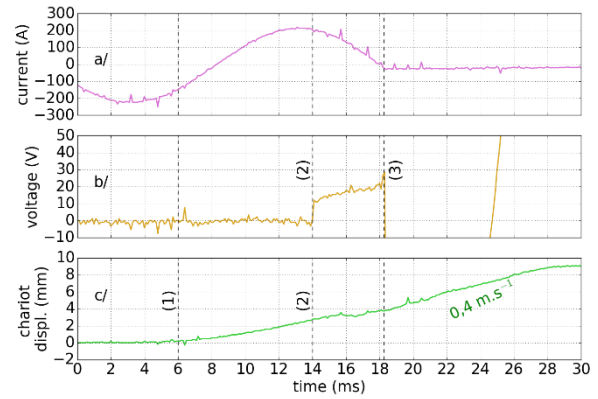
Fig. 2. Typical oscillogram of a/ current intensity, b/ contact voltage and c/ displacement of the mobile electrode carrier with a 150 A rms current; (1) mobile electrode carrier displacement begins, (2) contact opening and arc appearance, (3) arc disappearance.

A program based on LabView collects all the data. An example of current, voltage and displacement recorded is shown in Fig. 2. The calculator takes into account the spring characteristics so that the displacement of the mobile electrode carrier causes an opening leading to a 4 ms arc duration. It starts opening around 6 ms. At 14 ms, the contact is effectively opening and an arc is generated. The arc extends until it is extinguished when the current reaches zero at around 18 ms.

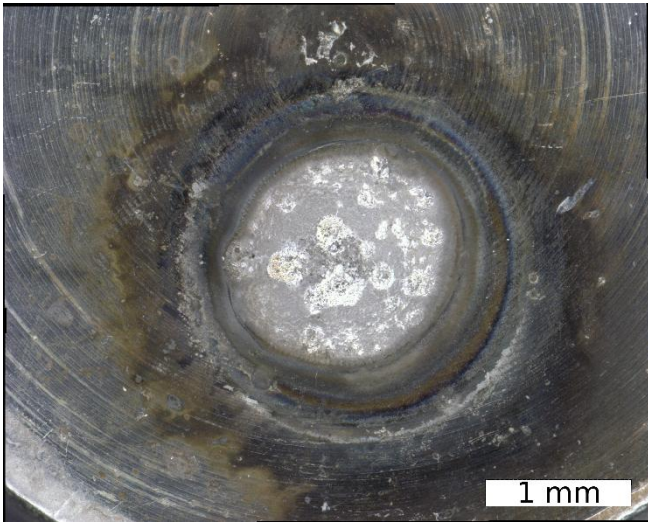
Fig. 4. A crater formed on an initially flat cathode surface after a single arc of 300 A rms.

The observation of a cathode surface has been made by optical microscopy (Fig.4). A crater on an initial flat cathode surface was formed after a single arc of 300 A rms. The inner part of the crater, of 1.6 mm in diameter, appears very bright. The surrounding area has clearly been affected by the arc.

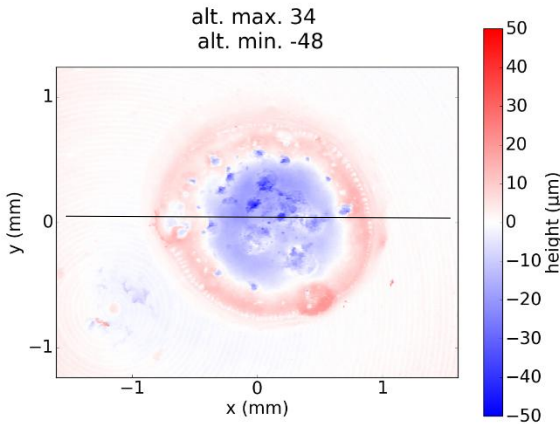
Fig. 5. Topography map of the initial flat cathode surface after a single electric arc (300 A rms) obtained with an optical profilometer.

Beyond this qualitative approach, an analysis by optical profilometry allows a more quantitative estimation of the surface damages. An example of such measurement is given in Fig. 5 which is a topography map. The zero altitude in white corresponds to the surface reference before the arc. After a single arc, two zones are visible. In the center of the crater, the height is negative and appears in blue. Around the crater, a red ring is visible (positive heights) which corresponds to displaced material within which there might be a presence of some gas bubbles. An estimation of the displaced volume (negative altitudes) gives a value of about  $10^{-2} \text{ mm}^3$ . This volume corresponds to a minimum of fused Ag-SnO<sub>2</sub> material. The fusion of such a volume requires an energy of 40 mJ, which is very few part of the total energy dissipated by the arc.

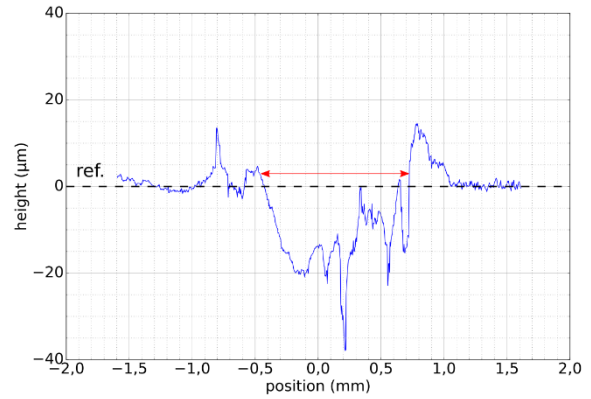
Fig. 6. Altitude surface profile obtained along the black line crossing the crater in Fig. 5.

The Fig. 5 allows to obtain a local altitude profile (Fig. 6), corresponding to the black line in Fig. 5. We observe that the bottom of the crater is quite irregular with hollows of 38  $\mu\text{m}$  maximum depth and the minimum diameter of molten material under the reference surface (in dashed line in Fig. 6) is around 1.1 mm.

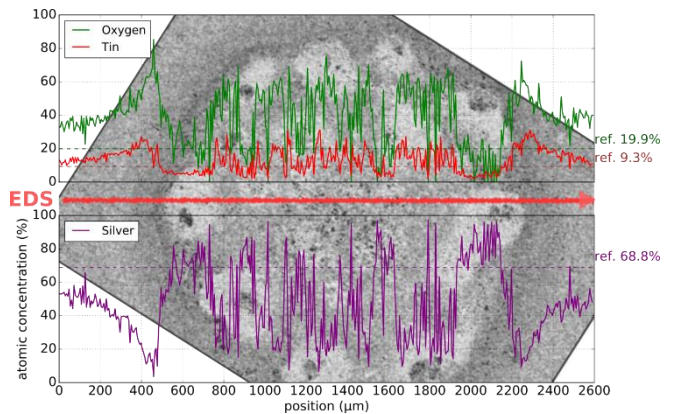
Fig. 7. Atomic concentration of Ag (purple), Sn (red) and O (green) measured by EDS along one of the crater diameters after a single arc (300 A rms – case of a flat cathode); the dashed lines are the mean values for each element measured using initial material.

A change in the topography can be possibly accompanied with a change in the concentration of the main elements. To get the chemical composition of the cathode surface (percentage of Ag, Sn and O elements) after a single arc, an energy dispersive spectroscopy (EDS) in scanning electron microscope (SEM) was used. The analysis was carried out along one of the crater diameters with a step of 2.5  $\mu\text{m}$  (Fig. 7). The dashed lines give the reference concentrations for each element measured before the arc. One can see that inside the crater, the concentrations are very variable. On the crater periphery, an Ag depletion and an increase in concentration of Sn and O are noticed. For the ease of reading, a SEM micrograph obtained using backscatter electrons is superimposed with the EDS profiles. Thus, we can conclude that the regions of bright contrast (and bright regions in Fig. 4) correspond to areas of quasi-pure Ag due to demixing after the arc action. Moreover, increased O content on the surface in comparison with that obtained using the reference sample suggests an intensive surface oxidation during the arc.

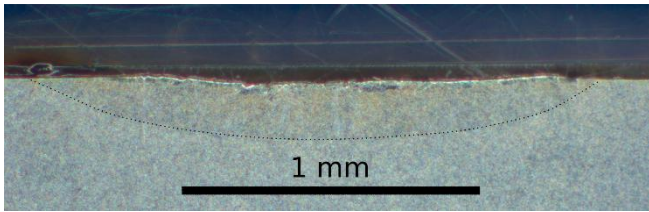
Fig. 8. Cathode microstructure in the cross section along a crater diameter after a single arc (300 A current – case of a flat cathode), observed with an optical microscope.

To get insight into different phenomena occurring during a single arc, the bulk of the samples close to the surface was observed using an optical microscope. The samples were cut along a diameter of the crater and further prepared by standard techniques. After polishing, a chemical etching (mix of ammoniac and hydrogen peroxide) was applied to reveal the cathode microstructure features (Fig. 8). A change

in the appearance of the material was observed on a lenticular sub surface volume whose dimensions are 1.9 mm in diameter and 200  $\mu\text{m}$  in depth.

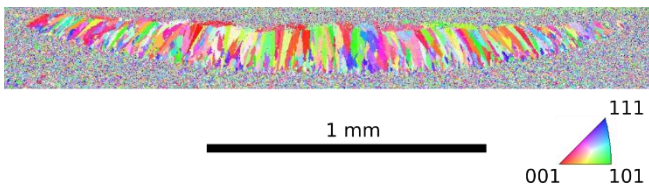
Fig. 9. Inverse pole figure for Ag in the direction normal to the sample surface obtained by EBSD analysis for the zone presented in figure 7. The colors indicate the orientation of the Ag grains.

To understand the origin of the contrast change in the subsurface area in Fig. 8, an analysis by electron backscatter diffraction (EBSD) was carried out (Fig. 9). One can observe that the initial microstructure (not affected by the arc) consists of relatively small grains not well resolved in Fig. 9. However, the sub surface area under the crater center reveals large Ag grains of different morphology with the largest grains of hundred microns in diameter. Such a grain structure is typical for solidification of the metals [11]. It suggests that the area containing large grains revealed by EBSD was melted by the arc. It is worth noting, however, that due to a very short arc action, we do not expect any significant Ag grain growth and all microstructure changes are attributed thus to melting with subsequent resolidification. The dimensions of the melted area thus observed are 1.85 mm for the diameter and 220  $\mu\text{m}$  for the depth. They are relatively similar to those obtained by optical microscopy (Fig. 8).

It is interesting to note that such observations make it possible to obtain the volume of molten material under the arc action. Thus we found a molten volume of around 0.3  $\text{mm}^3$ . The fusion of such a volume requires an energy of 1.2 J. It should also be noted that this volume is 30 times larger than the volume calculated from optical profilometer measurement. This shows that only a small amount of the molten liquid was set in motion by the action of the various arc-related forces (Laplace and Marangoni), probably due to the high viscosity of Ag-SnO<sub>2</sub>.

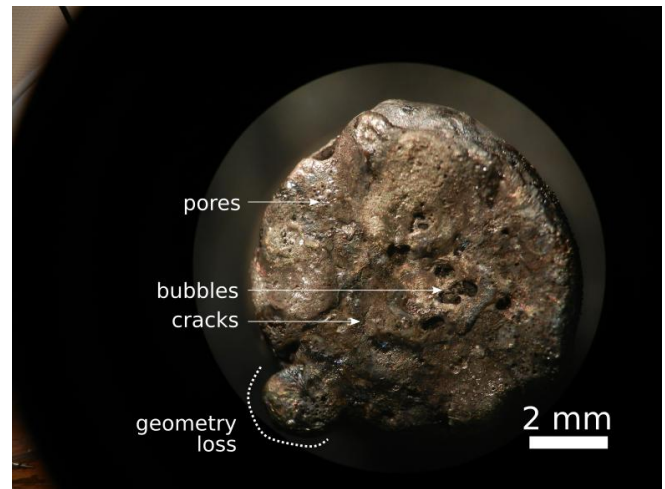
Fig. 10. Observation of an electrode surface impacted by 50,000 arcs at 300 A rms (optical microscopy).

In this section, the influence of the number of arcs on the degradation of the contact material is assessed. In these endurance tests the polarity changes with each arc. We will therefore no longer make a distinction between anode and cathode. Fig. 10 gives an observation by optical microscope of an electrode surface after 50,000 arcs (300 A rms). Numerous bubbles, pores, cracks as well as geometry loss (circular shape) may be observed.

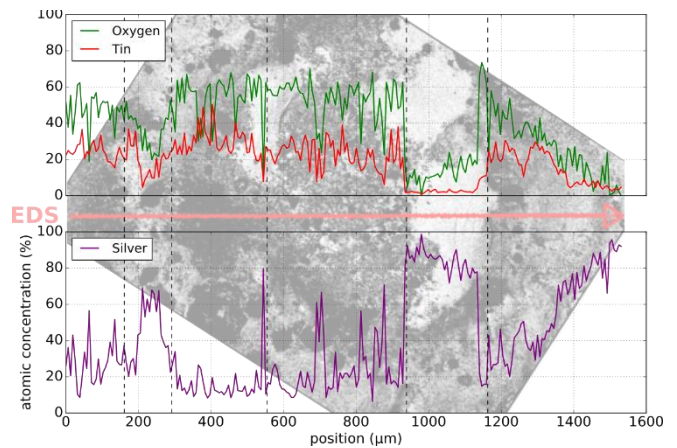
Fig. 11. Atomic concentration of Ag, Sn and O measured by EDS as a function of the position along the red line for an electrode was submitted to 50,000 arcs (300 A rms).

Since the entire surface has been modified, an optical profilometry analysis is of no interest. To evaluate how the element concentration has been affected, an EDS analysis was performed. The atomic concentration of the Ag, Sn and O elements as a function of the position along the red line is shown in Fig. 11. Areas of demixing can be observed: darker areas richer in tin and oxygen and poorer in silver and white areas particularly rich in silver.

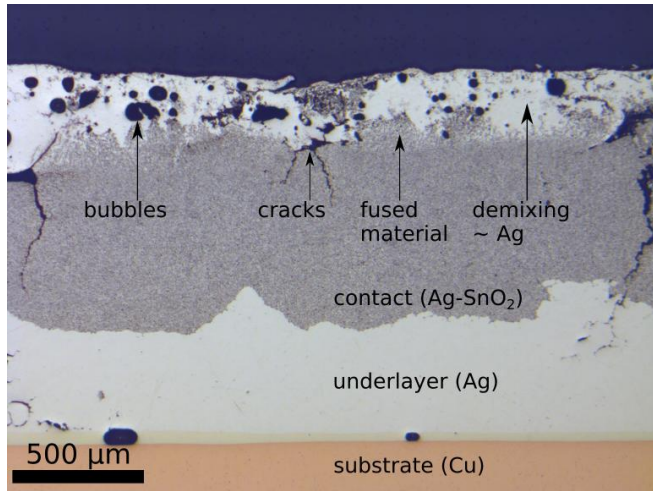
Fig. 12. Electrode microstructure in the cross section after 50,000 arcs (300 A rms) observed with an optical microscope.

In Fig. 12, an optical view of the cross section of the electrode is given. This makes it possible to see more clearly what appeared in Fig. 10, namely multiple bubbles, cracks, pores. In addition, demixing and melting zones are clearly distinguished.

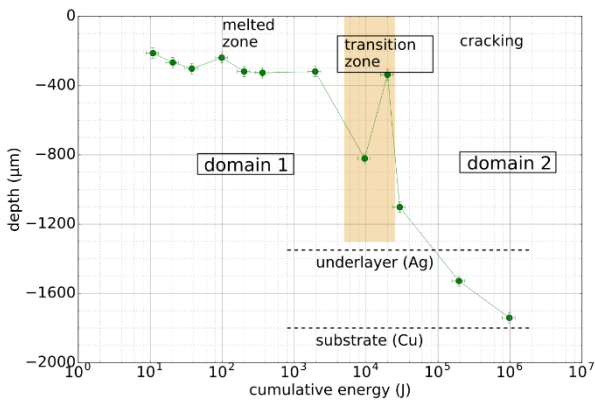
Fig. 13. Summary diagram of the depth of the deepest damage observed in relation to the surface as a function of the cumulative energy dissipated in the arcs.

The Fig. 13 shows on a summary diagram the depth of the deepest damage as a function of the energy dissipated in the arc cumulated on the successive arcs, named cumulative energy. It was obtained for different intensities of the arc current and also different numbers of successive arcs. Thus for the arc current intensities of 150, 300 and 600 A rms the average energy dissipated in the arc is respectively 10 J, 20 J and 40 J apart from a row. Two domains can be observed.

From  $10$  to  $3 \cdot 10^3$  J, the damage mainly observed is related to the existence of a molten volume that does not necessarily present demixing zones. The depth of this volume is almost constant and does not exceed  $400 \mu\text{m}$  deep. Beyond  $2 \cdot 10^4$  J damages are mainly related to vertical cracks formations. Cracks are growing quickly with the cumulative energy.

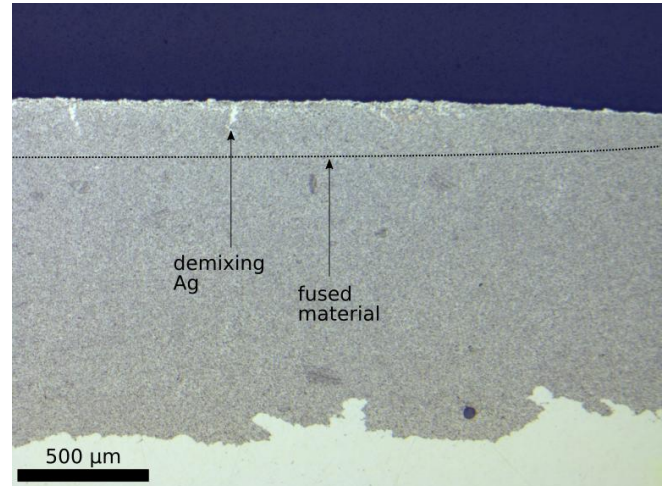
Fig. 14. Photograph of an electrode cross-section submitted to 10 arcs at 600 A rms.

An electrode submitted to 10 arcs at 600 A rms is chosen to illustrate this case (Fig.14). The estimated cumulative energy is about 400 J. The cross section shows a little demixing. A fused zone is visible deeper than the demixing. The depth of the fused material is around  $250 \mu\text{m}$ .

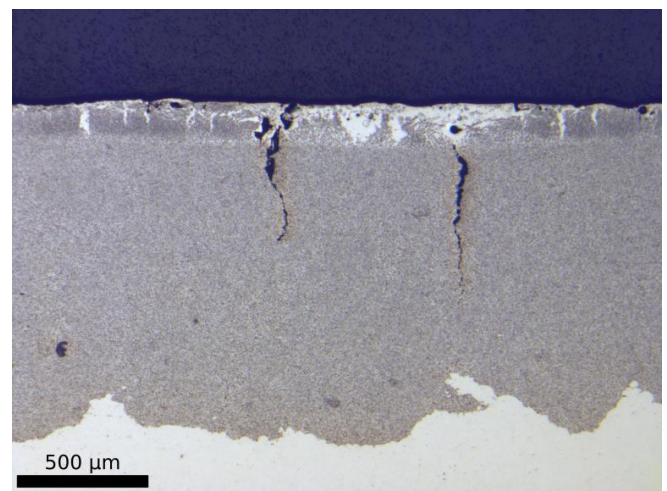
Fig. 15. Photograph of an electrode cross-section submitted to 1,000 arcs at 150 A rms.

Fig. 15 shows the cross section of an electrode submitted to 1,000 arcs at 150 A rms. The estimated cumulative energy is about 10 kJ. We can notice a clearer fusion front than in Fig. 14. The demixing is as deep as the fused material. Two vertical cracks can be observed in this figure from the surface towards the underlayer. The end of the deepest crack is  $800 \mu\text{m}$  deep.

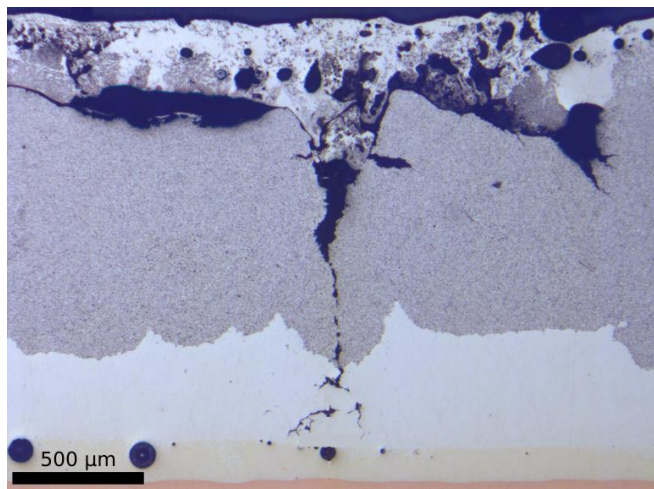
Fig. 16. Photography of an electrode cross-section submitted to 10,000 arcs at 300 A rms.

Fig. 16 shows the cross section of an electrode submitted to 10,000 arcs at 300 A rms. The estimated cumulative energy is about 200 kJ. The deepest damages observed are cracks which can almost extend to the braze. Surface damages are particularly severe. In addition to vertical cracks, horizontal ones appear and huge cavities are formed. Solid blocks of demixed material also appear and a lot of bubbles and pores are visible. What remains of the surface appears to be mechanically fragile.
