Observation of metallurgical changes induced by an electric arc to Ag-SnO₂-CuO electrodes

Aurélien Fouque, Georges Cailletaud, Vladimir A. Esin, Romaric Landfried, Philippe Testé, et al.. Observation of metallurgical changes induced by an electric arc to Ag-SnO₂-CuO electrodes. 65th IEEE Holm Conference on Electrical Contacts, Sep 2019, Milwaukee, United States. pp.239-244, 10.1109/HOLM.2019.8923681 . hal-02155532

Observation of metallurgical changes induced by an electric arc on Ag-SnO₂ electrodes

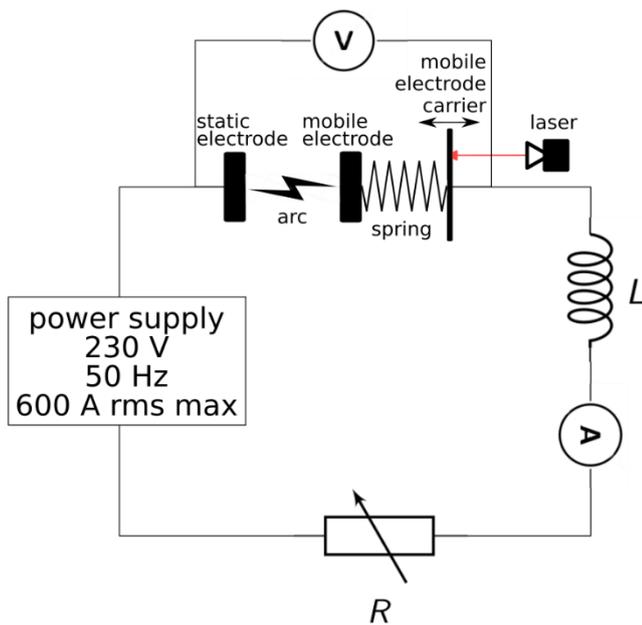
Fig. 1. Electrical circuit diagram; three values of resistances are used to get three current values 150, 300 and 600 A rms; the inductance value is set to get $\cos(\varphi)=0.35$; this machine enables to generate one or several arcs.

A schematic description of the electrical circuit considered in this work is shown in Fig. 1. The power supply is an alternative voltage source (230 V rms at 50 Hz) which can deliver a current up to 600 A rms. The current value is fixed by the choice of the resistor value. In this work, we focus on three current intensity values: 150, 300 and 600 A rms. The current in the circuit and the voltage measured between electrodes are recorded. The mobile part of the device is constituted of an electrode, a spring and a mobile electrode carrier. The spring ensures a contact force of 10 N. A laser measures the displacement of the mobile electrode carrier. As soon as the contact is open (contact force equals 0), this displacement corresponds to the electrode gap and it opens at a constant speed of around 0.4 m/s. This device has been used to generate a controlled number of opening arcs: from 1 to 50,000 arcs. Each making-breaking cycle lasts 1 second.

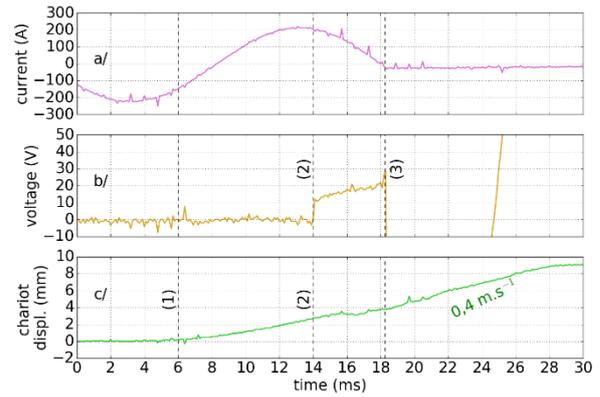
Fig. 2. Typical oscillogram of a/ current intensity, b/ contact voltage and c/ displacement of the mobile electrode carrier with a 150 A rms current; (1) mobile electrode carrier displacement begins, (2) contact opening and arc appearance, (3) arc disappearance.

A program based on LabView collects all the data. An example of current, voltage and displacement recorded is shown in Fig. 2. The calculator takes into account the spring characteristics so that the displacement of the mobile electrode carrier causes an opening leading to a 4 ms arc duration. It starts opening around 6 ms. At 14 ms, the contact is effectively opening and an arc is generated. The arc extends until it is extinguished when the current reaches zero at around 18 ms.

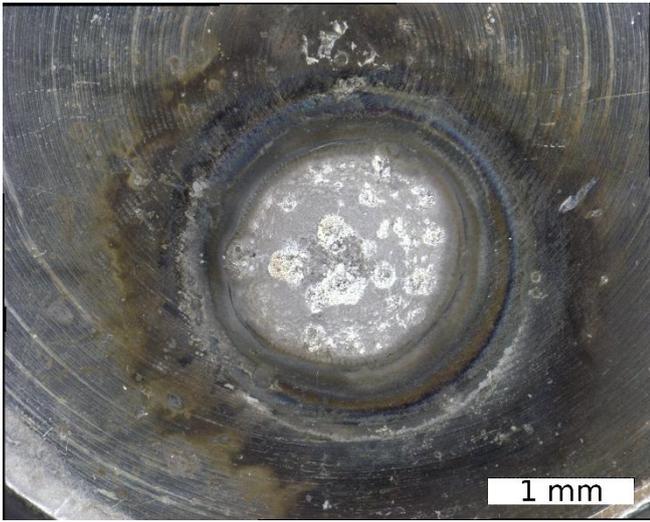
Fig. 4. A crater formed on an initially flat cathode surface after a single arc of 300 A rms.

The observation of a cathode surface has been made by optical microscopy (Fig.4). A crater on an initial flat cathode surface was formed after a single arc of 300 A rms. The inner part of the crater, of 1.6 mm in diameter, appears very bright. The surrounding area has clearly been affected by the arc.

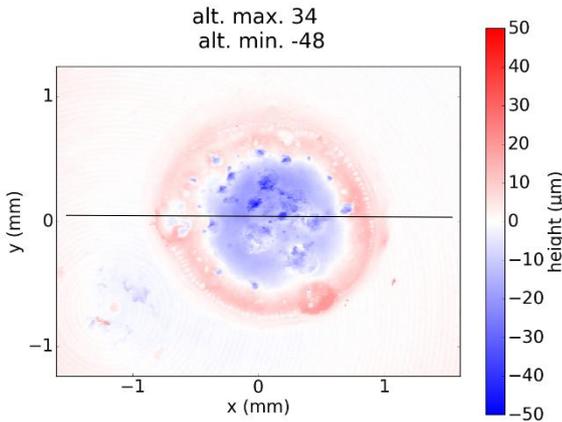
Fig. 5. Topography map of the initial flat cathode surface after a single electric arc (300 A rms) obtained with an optical profilometer.

Beyond this qualitative approach, an analysis by optical profilometry allows a more quantitative estimation of the surface damages. An example of such measurement is given in Fig. 5 which is a topography map. The zero altitude in white corresponds to the surface reference before the arc. After a single arc, two zones are visible. In the center of the crater, the height is negative and appears in blue. Around the crater, a red ring is visible (positive heights) which corresponds to displaced material within which there might be a presence of some gas bubbles. An estimation of the displaced volume (negative altitudes) gives a value of about 10^{-2} mm^3 . This volume corresponds to a minimum of fused Ag-SnO₂ material. The fusion of such a volume requires an energy of 40 mJ, which is very few part of the total energy dissipated by the arc.

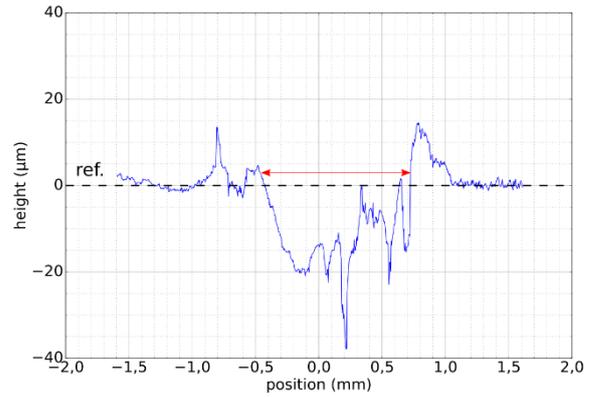
Fig. 6. Altitude surface profile obtained along the black line crossing the crater in Fig. 5.

The Fig. 5 allows to obtain a local altitude profile (Fig. 6), corresponding to the black line in Fig. 5. We observe that the bottom of the crater is quite irregular with hollows of 38 μm maximum depth and the minimum diameter of molten material under the reference surface (in dashed line in Fig. 6) is around 1.1 mm.

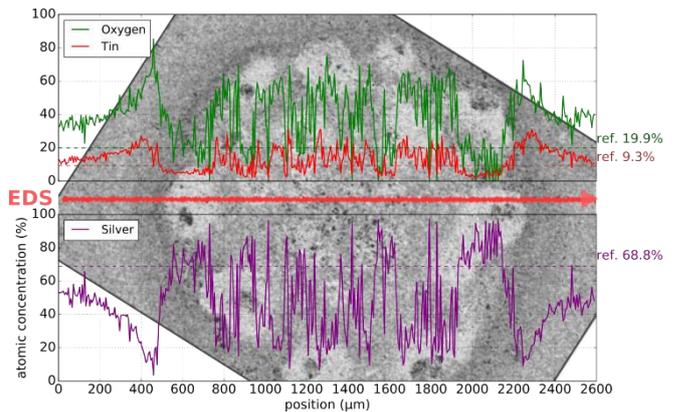
Fig. 7. Atomic concentration of Ag (purple), Sn (red) and O (green) measured by EDS along one of the crater diameters after a single arc (300 A rms – case of a flat cathode); the dashed lines are the mean values for each element measured using initial material.

A change in the topography can be possibly accompanied with a change in the concentration of the main elements. To get the chemical composition of the cathode surface (percentage of Ag, Sn and O elements) after a single arc, an energy dispersive spectroscopy (EDS) in scanning electron microscope (SEM) was used. The analysis was carried out along one of the crater diameters with a step of 2.5 μm (Fig. 7). The dashed lines give the reference concentrations for each element measured before the arc. One can see that inside the crater, the concentrations are very variable. On the crater periphery, an Ag depletion and an increase in concentration of Sn and O are noticed. For the ease of reading, a SEM micrograph obtained using backscatter electrons is superimposed with the EDS profiles. Thus, we can conclude that the regions of bright contrast (and bright regions in Fig. 4) correspond to areas of quasi-pure Ag due to demixing after the arc action. Moreover, increased O content on the surface in comparison with that obtained using the reference sample suggests an intensive surface oxidation during the arc.

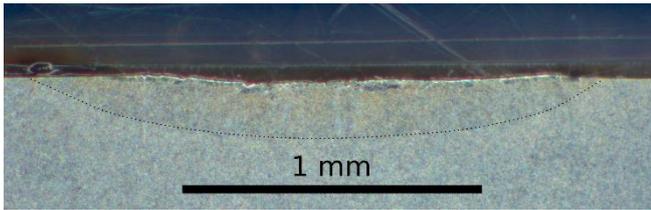
Fig. 8. Cathode microstructure in the cross section along a crater diameter after a single arc (300 A current – case of a flat cathode), observed with an optical microscope.

To get insight into different phenomena occurring during a single arc, the bulk of the samples close to the surface was observed using an optical microscope. The samples were cut along a diameter of the crater and further prepared by standard techniques. After polishing, a chemical etching (mix of ammoniac and hydrogen peroxide) was applied to reveal the cathode microstructure features (Fig. 8). A change

in the appearance of the material was observed on a lenticular sub surface volume whose dimensions are 1.9 mm in diameter and 200 μm in depth.

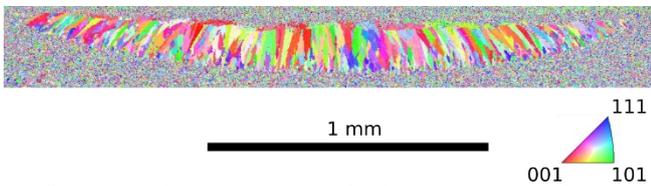
Fig. 9. Inverse pole figure for Ag in the direction normal to the sample surface obtained by EBSD analysis for the zone presented in figure 7. The colors indicate the orientation of the Ag grains.

To understand the origin of the contrast change in the subsurface area in Fig. 8, an analysis by electron backscatter diffraction (EBSD) was carried out (Fig. 9). One can observe that the initial microstructure (not affected by the arc) consists of relatively small grains not well resolved in Fig. 9. However, the sub surface area under the crater center reveals large Ag grains of different morphology with the largest grains of hundred microns in diameter. Such a grain structure is typical for solidification of the metals [11]. It suggests that the area containing large grains revealed by EBSD was melted by the arc. It is worth noting, however, that due to a very short arc action, we do not expect any significant Ag grain growth and all microstructure changes are attributed thus to melting with subsequent resolidification. The dimensions of the melted area thus observed are 1.85 mm for the diameter and 220 μm for the depth. They are relatively similar to those obtained by optical microscopy (Fig. 8).

It is interesting to note that such observations make it possible to obtain the volume of molten material under the arc action. Thus we found a molten volume of around 0.3 mm^3 . The fusion of such a volume requires an energy of 1.2 J. It should also be noted that this volume is 30 times larger than the volume calculated from optical profilometer measurement. This shows that only a small amount of the molten liquid was set in motion by the action of the various arc-related forces (Laplace and Marangoni), probably due to the high viscosity of Ag-SnO₂.

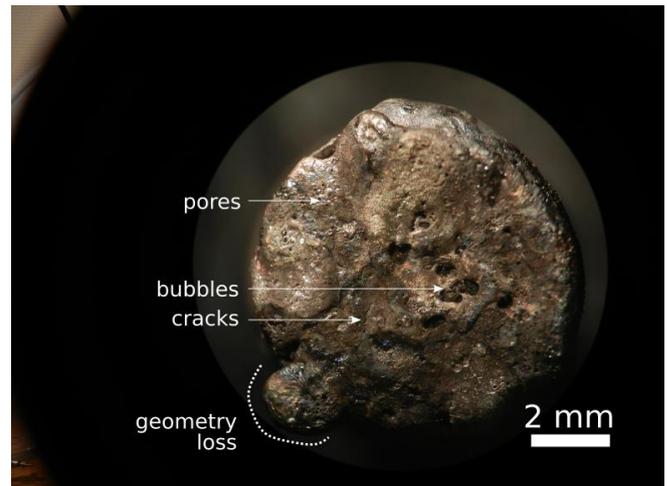
Fig. 10. Observation of an electrode surface impacted by 50,000 arcs at 300 A rms (optical microscopy).

In this section, the influence of the number of arcs on the degradation of the contact material is assessed. In these endurance tests the polarity changes with each arc. We will therefore no longer make a distinction between anode and cathode. Fig. 10 gives an observation by optical microscope of an electrode surface after 50,000 arcs (300 A rms). Numerous bubbles, pores, cracks as well as geometry loss (circular shape) may be observed.

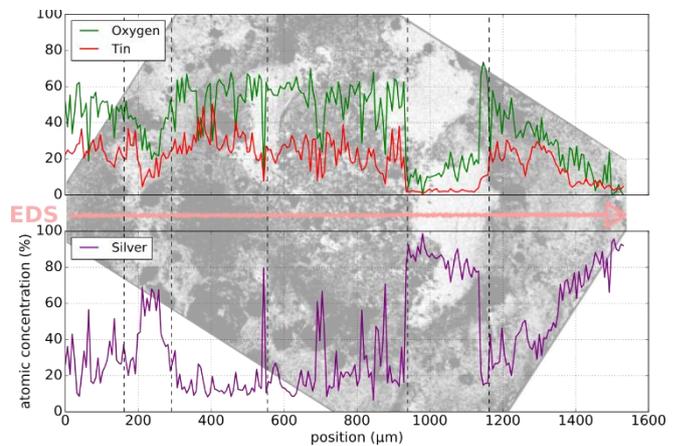
Fig. 11. Atomic concentration of Ag, Sn and O measured by EDS as a function of the position along the red line for an electrode was submitted to 50,000 arcs (300 A rms).

Since the entire surface has been modified, an optical profilometry analysis is of no interest. To evaluate how the element concentration has been affected, an EDS analysis was performed. The atomic concentration of the Ag, Sn and O elements as a function of the position along the red line is shown in Fig. 11. Areas of demixing can be observed: darker areas richer in tin and oxygen and poorer in silver and white areas particularly rich in silver.

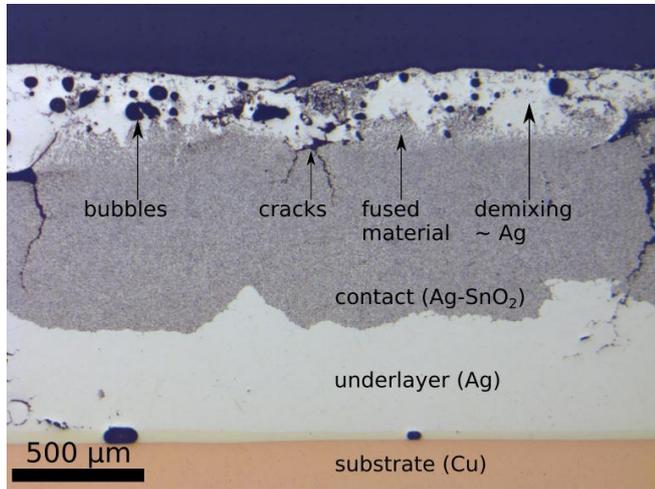
Fig. 12. Electrode microstructure in the cross section after 50,000 arcs (300 A rms) observed with an optical microscope.

In Fig. 12, an optical view of the cross section of the electrode is given. This makes it possible to see more clearly what appeared in Fig. 10, namely multiple bubbles, cracks, pores. In addition, demixing and melting zones are clearly distinguished.

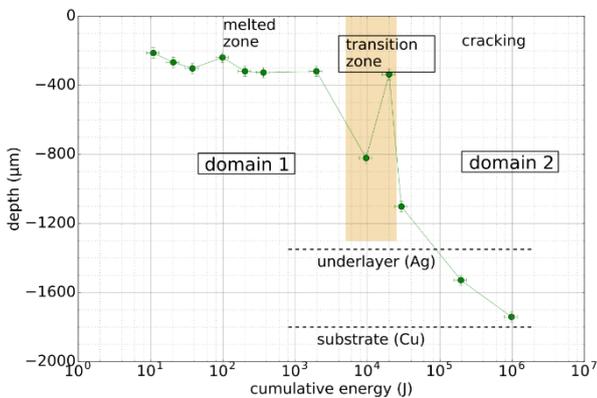
Fig. 13. Summary diagram of the depth of the deepest damage observed in relation to the surface as a function of the cumulative energy dissipated in the arcs.

The Fig. 13 shows on a summary diagram the depth of the deepest damage as a function of the energy dissipated in the arc cumulated on the successive arcs, named cumulative energy. It was obtained for different intensities of the arc current and also different numbers of successive arcs. Thus for the arc current intensities of 150, 300 and 600 A rms the average energy dissipated in the arc is respectively 10 J, 20 J and 40 J apart from a row. Two domains can be observed.

From 10 to $3 \cdot 10^3$ J, the damage mainly observed is related to the existence of a molten volume that does not necessarily present demixing zones. The depth of this volume is almost constant and does not exceed 400 µm deep. Beyond $2 \cdot 10^4$ J damages are mainly related to vertical cracks formations. Cracks are growing quickly with the cumulative energy.

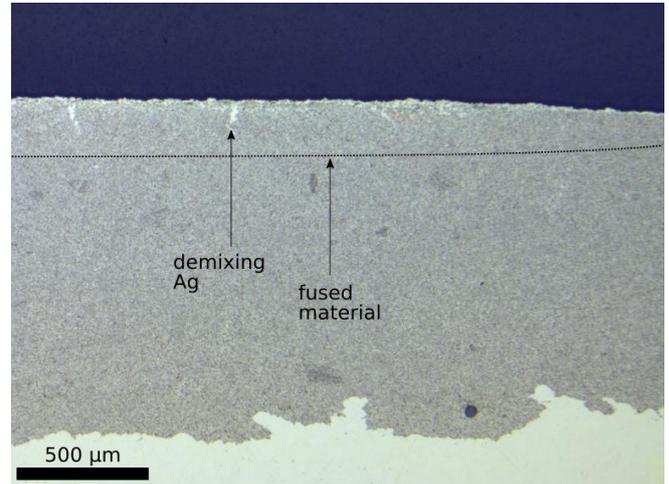
Fig. 14. Photograph of an electrode cross-section submitted to 10 arcs at 600 A rms.

An electrode submitted to 10 arcs at 600 A rms is chosen to illustrate this case (Fig.14). The estimated cumulative energy is about 400 J. The cross section shows a little demixing. A fused zone is visible deeper than the demixing. The depth of the fused material is around 250 µm.

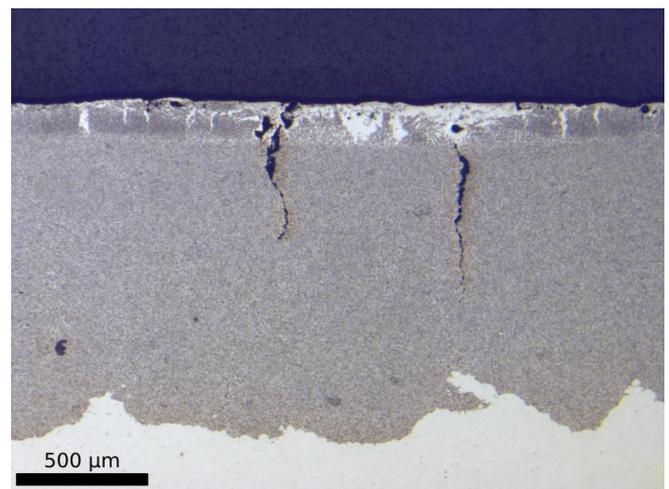
Fig. 15. Photograph of an electrode cross-section submitted to 1,000 arcs at 150 A rms.

Fig. 15 shows the cross section of an electrode submitted to 1,000 arcs at 150 A rms. The estimated cumulative energy is about 10 kJ. We can notice a clearer fusion front than in Fig. 14. The demixing is as deep as the fused material. Two vertical cracks can be observed in this figure from the surface towards the underlayer. The end of the deepest crack is 800 µm deep.

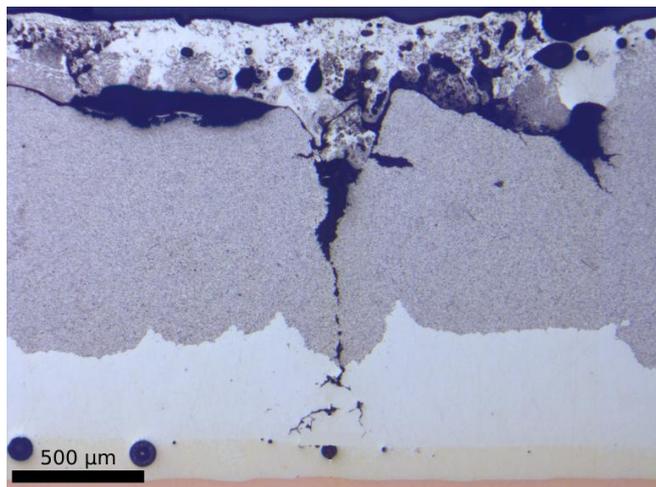
Fig. 16. Photography of an electrode cross-section submitted to 10,000 arcs at 300 A rms.

Fig. 16 shows the cross section of an electrode submitted to 10,000 arcs at 300 A rms. The estimated cumulative energy is about 200 kJ. The deepest damages observed are cracks which can almost extend to the braze. Surface damages are particularly severe. In addition to vertical cracks, horizontal ones appear and huge cavities are formed. Solid blocks of demixed material also appear and a lot of bubbles and pores are visible. What remains of the surface appears to be mechanically fragile.
