Observation of metallurgical changes induced by an electric arc to Ag-SnO₂-CuO electrodes

Aurélien Fouque, Georges Cailletaud, Vladimir A. Esin, Romaric Landfried, Philippe Testé, et al.. Observation of metallurgical changes induced by an electric arc to Ag-SnO₂-CuO electrodes. 65th IEEE Holm Conference on Electrical Contacts, Sep 2019, Milwaukee, United States. pp.239-244, 10.1109/HOLM.2019.8923681 . hal-02155532

Observation of metallurgical changes induced by an electric arc on Ag-SnO₂ electrodes

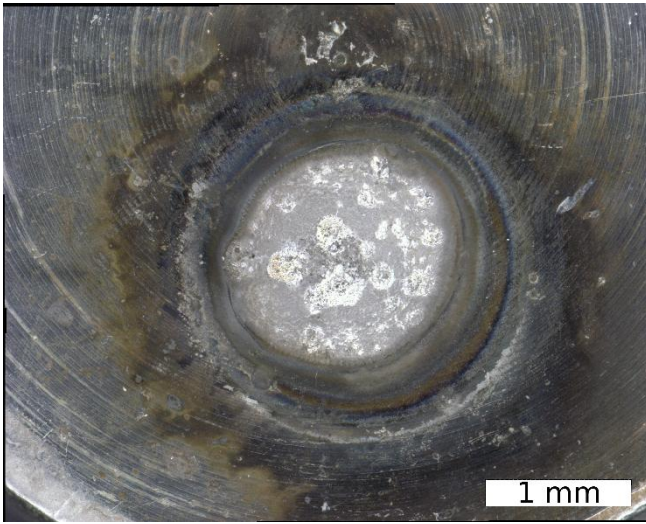
Fig. 4. A crater formed on an initially flat cathode surface after a single arc of 300 A rms.

The observation of a cathode surface has been made by optical microscopy (Fig.4). A crater on an initial flat cathode surface was formed after a single arc of 300 A rms. The inner part of the crater, of 1.6 mm in diameter, appears very bright. The surrounding area has clearly been affected by the arc.

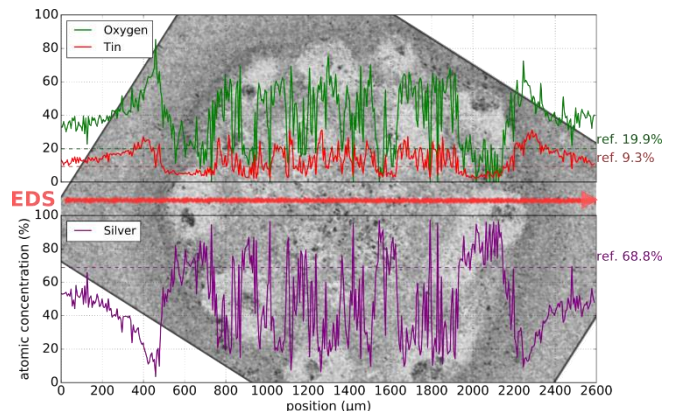
Fig. 7. Atomic concentration of Ag (purple), Sn (red) and O (green) measured by EDS along one of the crater diameters after a single arc (300 A rms – case of a flat cathode); the dashed lines are the mean values for each element measured using initial material.

A change in the topography can be possibly accompanied with a change in the concentration of the main elements. To get the chemical composition of the cathode surface (percentage of Ag, Sn and O elements) after a single arc, an energy dispersive spectroscopy (EDS) in scanning electron microscope (SEM) was used. The analysis was carried out along one of the crater diameters with a step of 2.5 μm (Fig. 7). The dashed lines give the reference concentrations for each element measured before the arc. One can see that inside the crater, the concentrations are very variable. On the crater periphery, an Ag depletion and an increase in concentration of Sn and O are noticed. For the ease of reading, a SEM micrograph obtained using backscatter electrons is superimposed with the EDS profiles. Thus, we can conclude that the regions of bright contrast (and bright regions in Fig. 4) correspond to areas of quasi-pure Ag due to demixing after the arc action. Moreover, increased O content on the surface in comparison with that obtained using the reference sample suggests an intensive surface oxidation during the arc.

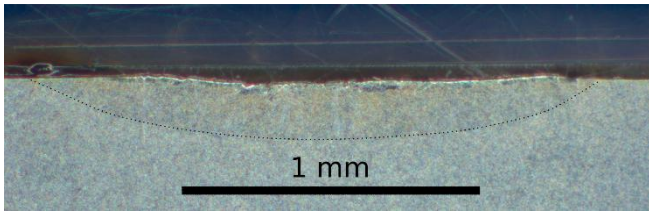
Fig. 8. Cathode microstructure in the cross section along a crater diameter after a single arc (300 A current – case of a flat cathode), observed with an optical microscope.

To get insight into different phenomena occurring during a single arc, the bulk of the samples close to the surface was observed using an optical microscope. The samples were cut along a diameter of the crater and further prepared by standard techniques. After polishing, a chemical etching (mix of ammoniac and hydrogen peroxide) was applied to reveal the cathode microstructure features (Fig. 8). A change

in the appearance of the material was observed on a lenticular sub surface volume whose dimensions are 1.9 mm in diameter and 200 μm in depth.

To understand the origin of the contrast change in the subsurface area in Fig. 8, an analysis by electron backscatter diffraction (EBSD) was carried out (Fig. 9). One can observe that the initial microstructure (not affected by the arc) consists of relatively small grains not well resolved in Fig. 9. However, the sub surface area under the crater center reveals large Ag grains of different morphology with the largest grains of hundred microns in diameter. Such a grain structure is typical for solidification of the metals [11]. It suggests that the area containing large grains revealed by EBSD was melted by the arc. It is worth noting, however, that due to a very short arc action, we do not expect any significant Ag grain growth and all microstructure changes are attributed thus to melting with subsequent resolidification. The dimensions of the melted area thus observed are 1.85 mm for the diameter and 220 μm for the depth. They are relatively similar to those obtained by optical microscopy (Fig. 8).

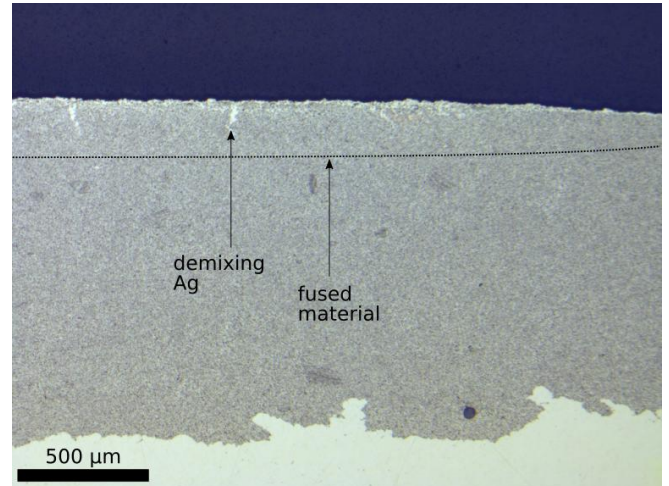
Fig. 14. Photograph of an electrode cross-section submitted to 10 arcs at 600 A rms.

An electrode submitted to 10 arcs at 600 A rms is chosen to illustrate this case (Fig.14). The estimated cumulative energy is about 400 J. The cross section shows a little demixing. A fused zone is visible deeper than the demixing. The depth of the fused material is around $250 \mu\text{m}$.

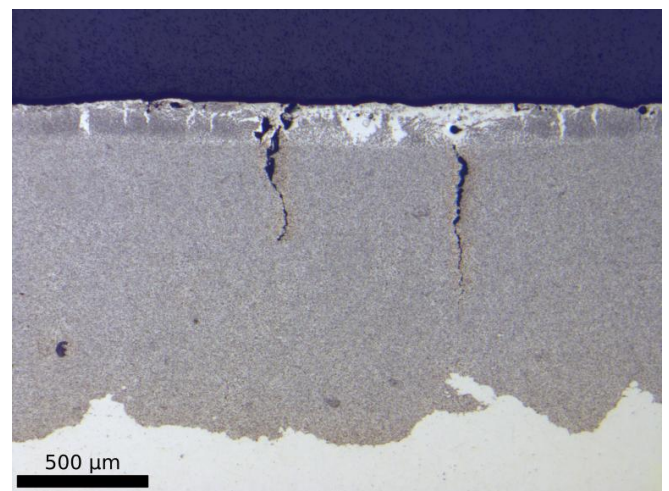
Fig. 15. Photograph of an electrode cross-section submitted to 1,000 arcs at 150 A rms.

Fig. 15 shows the cross section of an electrode submitted to 1,000 arcs at 150 A rms. The estimated cumulative energy is about 10 kJ. We can notice a clearer fusion front than in Fig. 14. The demixing is as deep as the fused material. Two vertical cracks can be observed in this figure from the surface towards the underlayer. The end of the deepest crack is $800 \mu\text{m}$ deep.
