## Observation of metallurgical changes induced by an electric arc to Ag-SnO<sub>2</sub>-CuO electrodes

# Observation of metallurgical changes induced by an electric arc on Ag-SnO<sub>2</sub> electrodes

**Abstract** — Understanding the erosion of contact materials caused by electric arcs is a major challenge to improve the lifetime of switching devices. The main purpose of this study is to determine how the silver-tin oxide material (Ag-SnO<sub>2</sub> 12%w.) evolves under the action of a unique arc and multiple arcs (up to 50,000). Pairs of electrodes were submitted to an opening arc at room atmosphere for current intensity of 150, 300 and 600 A rms and typical duration of 4 ms. Different means of characterization were used: optical microscopy, optical profilometry, energy dispersive spectroscopy (EDS) of the electrode surface, electron backscatter diffraction (EBSD). For a unique arc, it was possible to observe a resolidified molten zone and estimate its dimensions. The influence of the number of arcs has been studied and a gradual evolution of the damage nature has been demonstrated as a function of the arc numbers.

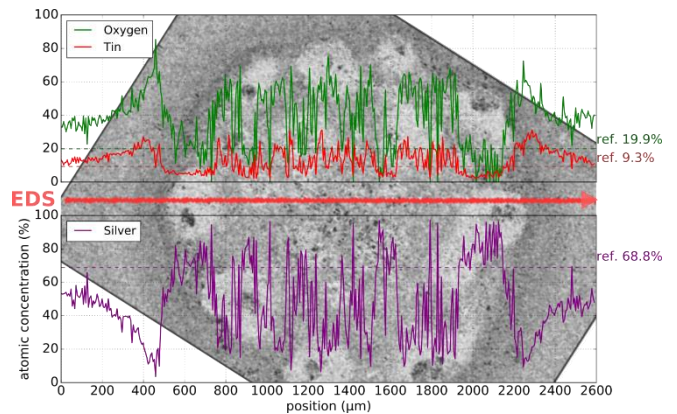
Fig. 7. Atomic concentration of Ag (purple), Sn (red) and O (green) measured by EDS along one of the crater diameters after a single arc (300 A rms – case of a flat cathode); the dashed lines are the mean values for each element measured using initial material.

A change in the topography can be possibly accompanied with a change in the concentration of the main elements. To get the chemical composition of the cathode surface (percentage of Ag, Sn and O elements) after a single arc, an energy dispersive spectroscopy (EDS) in scanning electron microscope (SEM) was used. The analysis was carried out along one of the crater diameters with a step of 2.5  $\mu\text{m}$  (Fig. 7). The dashed lines give the reference concentrations for each element measured before the arc. One can see that inside the crater, the concentrations are very variable. On the crater periphery, an Ag depletion and an increase in concentration of Sn and O are noticed. For the ease of reading, a SEM micrograph obtained using backscatter electrons is superimposed with the EDS profiles. Thus, we can conclude that the regions of bright contrast (and bright regions in Fig. 4) correspond to areas of quasi-pure Ag due to demixing after the arc action. Moreover, increased O content on the surface in comparison with that obtained using the reference sample suggests an intensive surface oxidation during the arc.

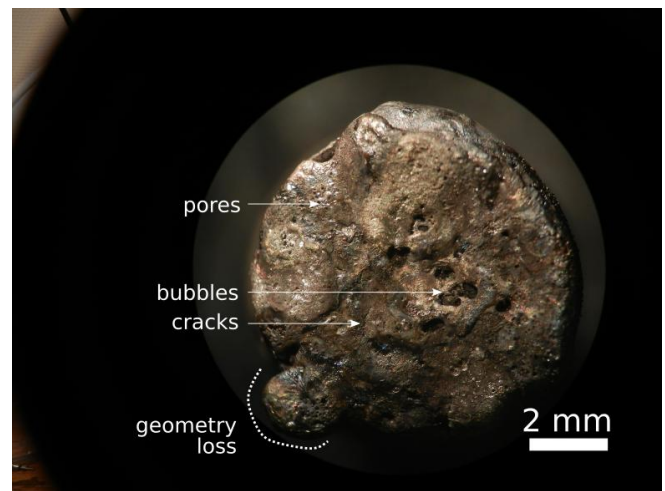
Fig. 10. Observation of an electrode surface impacted by 50,000 arcs at 300 A rms (optical microscopy).

In this section, the influence of the number of arcs on the degradation of the contact material is assessed. In these endurance tests the polarity changes with each arc. We will therefore no longer make a distinction between anode and cathode. Fig. 10 gives an observation by optical microscope of an electrode surface after 50,000 arcs (300 A rms). Numerous bubbles, pores, cracks as well as geometry loss (circular shape) may be observed.

In Fig. 12, an optical view of the cross section of the electrode is given. This makes it possible to see more clearly what appeared in Fig. 10, namely multiple bubbles, cracks, pores. In addition, demixing and melting zones are clearly distinguished.
