Observation of metallurgical changes induced by an electric arc to Ag-SnO₂-CuO electrodes

Aurélien Fouque, Georges Cailletaud, Vladimir A. Esin, Romaric Landfried, Philippe Testé, et al.. Observation of metallurgical changes induced by an electric arc to Ag-SnO₂-CuO electrodes. 65th IEEE Holm Conference on Electrical Contacts, Sep 2019, Milwaukee, United States. pp.239-244, 10.1109/HOLM.2019.8923681 . hal-02155532

Observation of metallurgical changes induced by an electric arc on Ag-SnO₂ electrodes

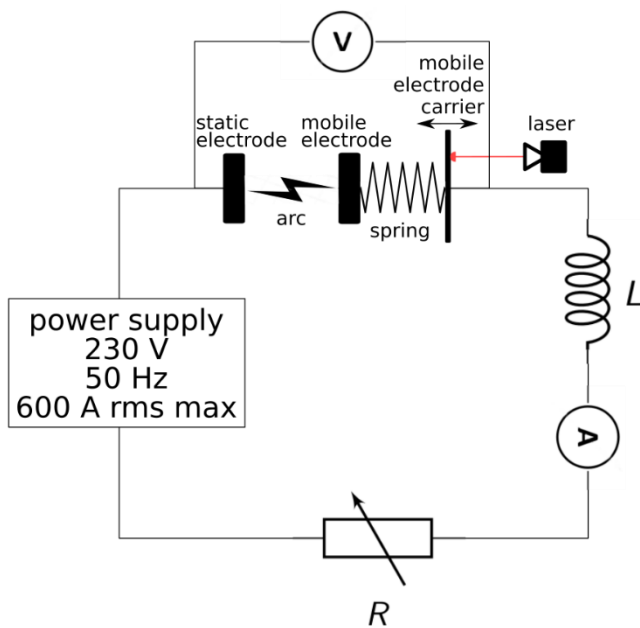
Fig. 1. Electrical circuit diagram; three values of resistances are used to get three current values 150, 300 and 600 A rms; the inductance value is set to get $\cos(\varphi)=0.35$; this machine enables to generate one or several arcs.

A schematic description of the electrical circuit considered in this work is shown in Fig. 1. The power supply is an alternative voltage source (230 V rms at 50 Hz) which can deliver a current up to 600 A rms. The current value is fixed by the choice of the resistor value. In this work, we focus on three current intensity values: 150, 300 and 600 A rms. The current in the circuit and the voltage measured between electrodes are recorded. The mobile part of the device is constituted of an electrode, a spring and a mobile electrode carrier. The spring ensures a contact force of 10 N. A laser measures the displacement of the mobile electrode carrier. As soon as the contact is open (contact force equals 0), this displacement corresponds to the electrode gap and it opens at a constant speed of around 0.4 m/s. This device has been used to generate a controlled number of opening arcs: from 1 to 50,000 arcs. Each making-breaking cycle lasts 1 second.
