Observation of arc fault in aeronautical conditions

Mohamed Boukhelifa, Romaric Landfried, Thomas Klonowski, Thierry Leblanc, Philippe Teste. Observation of arc fault in aeronautical conditions. MEA 2021 More Electric Aircraft, 3AF & SEE, Oct 2021, Bordeaux, France. pp.P2.10. hal-03451497

Observation of the phase before DC arc fault apparition in wet conditions

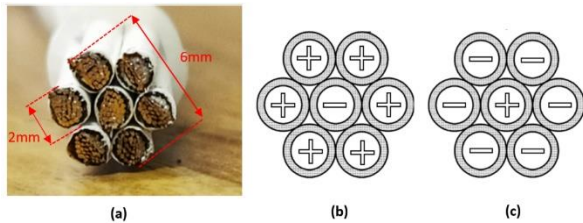
Fig. 2: a: photograph of harness with seven aeronautical cables, b: negative polarity, c: positive polarity

The experimental bench is presented in fig. 1. It's a wet arc tracking test bench, based on the initiation of a fault to wiring harness by a contaminating fluid (in our case salt water with controlled salinity, namely 30g / L) and corresponds to the recommendations of the AC standard (FprEN 3475-605). The polarity of the sample adjusted for direct current tests is described in figures 2. b and 2. c.

The reference cable used in the tests is: ASNE0261 CF 14, Polyimide tape – white, ASNE (Airbus) High Temperature Wire & Cable. Voltage Rating: 600 V. Temperature Ratings: -55°C to +200°C, used in the European aerospace industry [4].

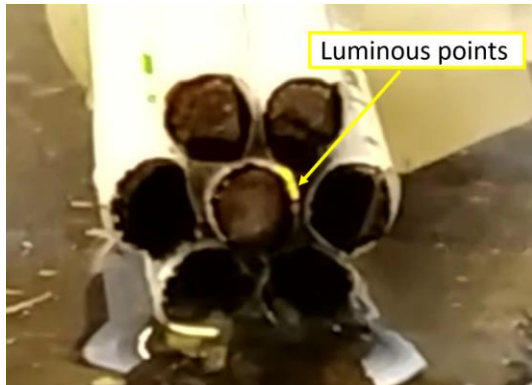
Fig. 5: second step of crackle: appearance of light points,

- "crackling" noise (hence its name) in an audible frequency range (20 Hz-20 kHz), the voltage of the fault equals to supply voltage.
- Appearance of a sort of foam due to the fault current that is presented in the fig. 4.
- Appearance of luminous points on the surface of the insulation of the central cable (either anode or cathode) fig. 5 and 6.
- Appearance of luminous points on the surface of the anode core which is presented in fig. 7.

- ❖ **Second step:** appearance of luminous points / increase in the number of luminous points (fig. 5 and 6). The end of this stage is distinguished by the appearance of a ring shape formed by the luminous points on the surface of the insulation of the center cable. This is accompanied by further disturbances of electrical signals with current peaks that can

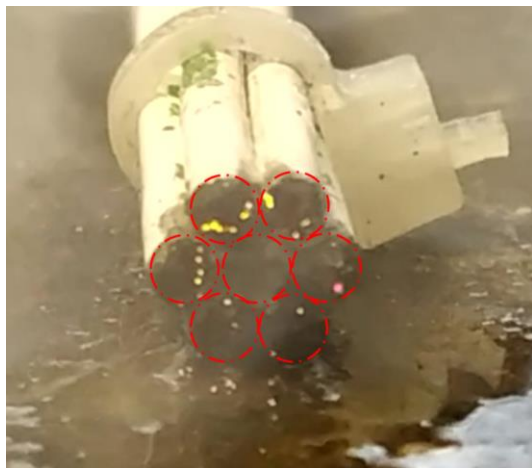
Fig. 7: third step of crackle: appearance of luminous points on the surface of the anode core and degradation of the anode.

Third step: appearance of luminous points on the surface of the anode core, a higher fault current intensity than for the other steps with current peaks of the order of magnitude up to a few amps. This step is also characterized by decomposition of the anode. (fig. 7), and this is the step that causes more degradation on the wire harness due to the decomposition of anode core like in the fig. 8, The average value of power dissipated in the fault around to 10 W.

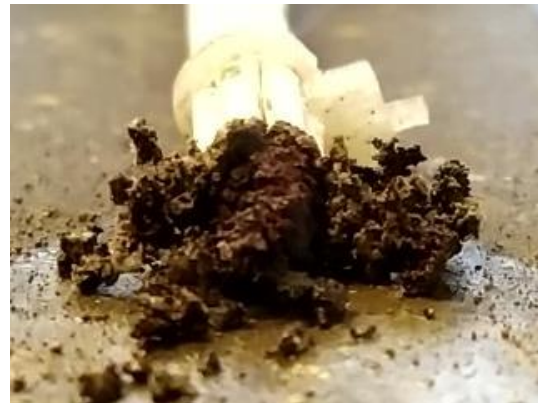
fig. 8: damage caused by the crackle on the harness
